# Adjusting Set Screw on Loader

# Getting Started

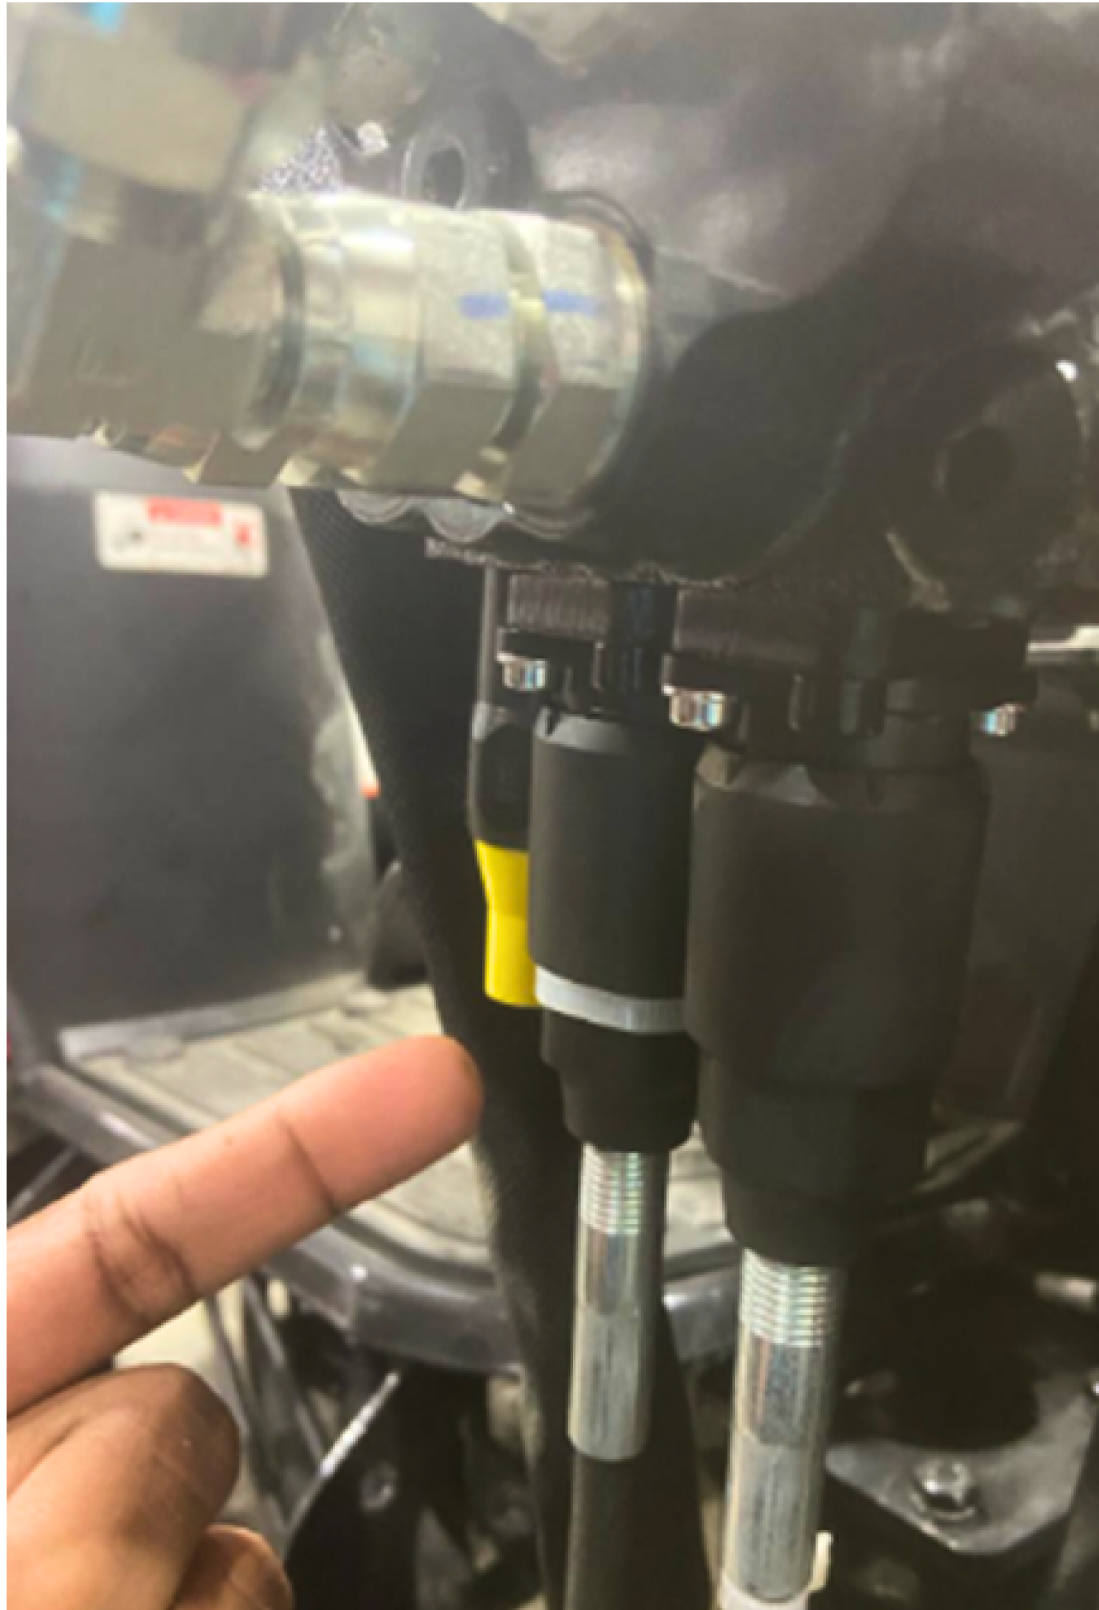
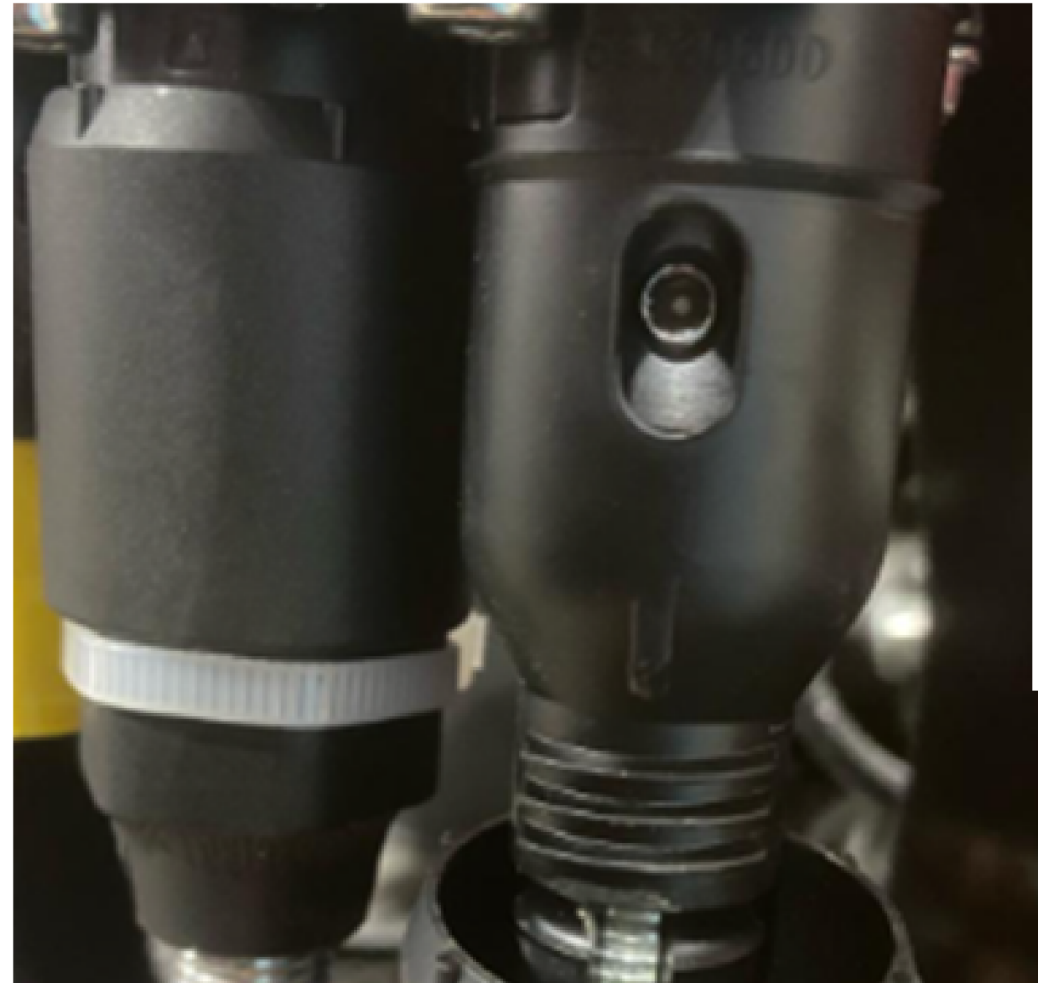
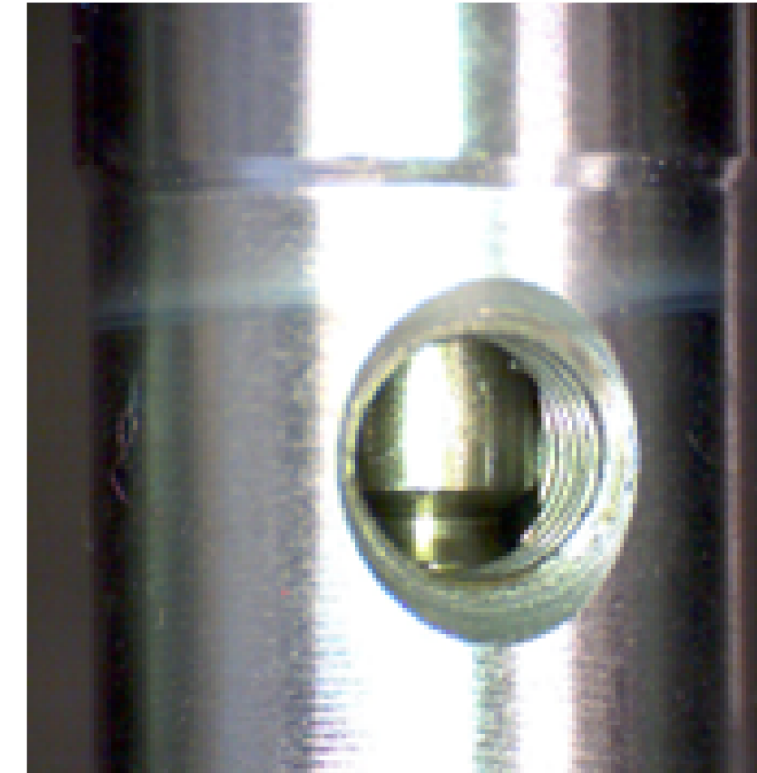
## Step 1: Loader Joystick Cable

Identify the plastic covers over the loader cables.

These plastic covers can be turned out by moving counterclockwise

Remove the set-screw using allen hex key 3mm

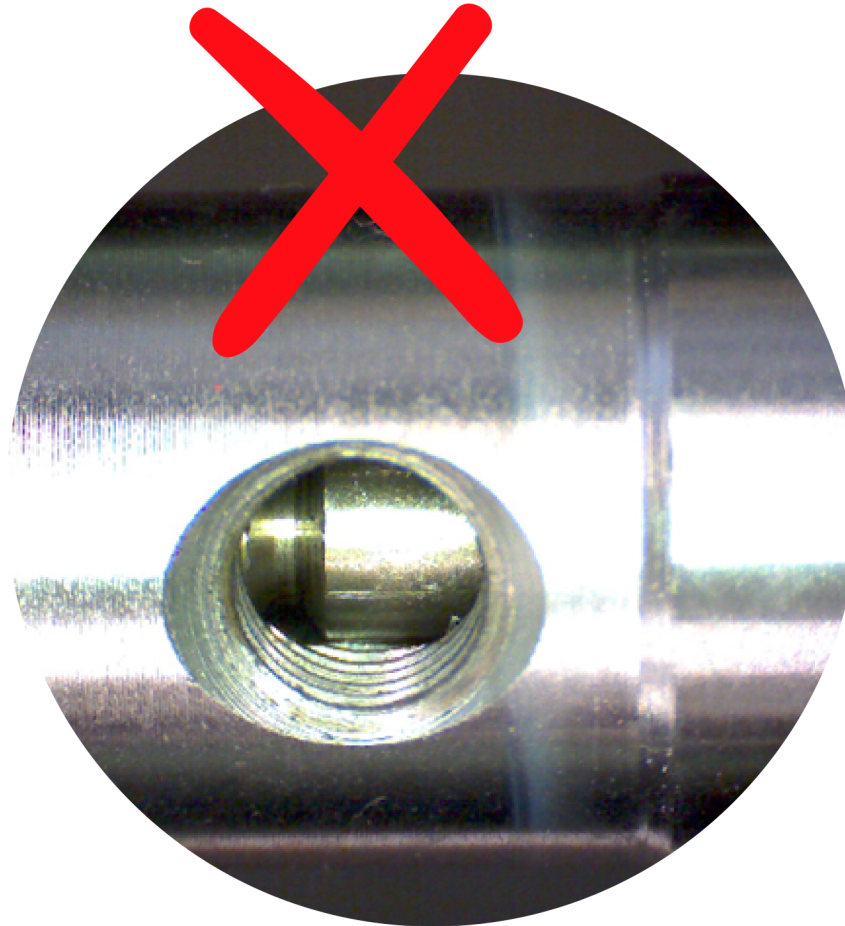
Cable NOT  
inserted far  
enough

**Incorrect installation can lead to damage to the cable by the set screw. The set screw is pointed and designed to engage both walls of the groove in the cable. Secure to  $9\text{Nm} \pm 1\text{Nm.s}$ )**

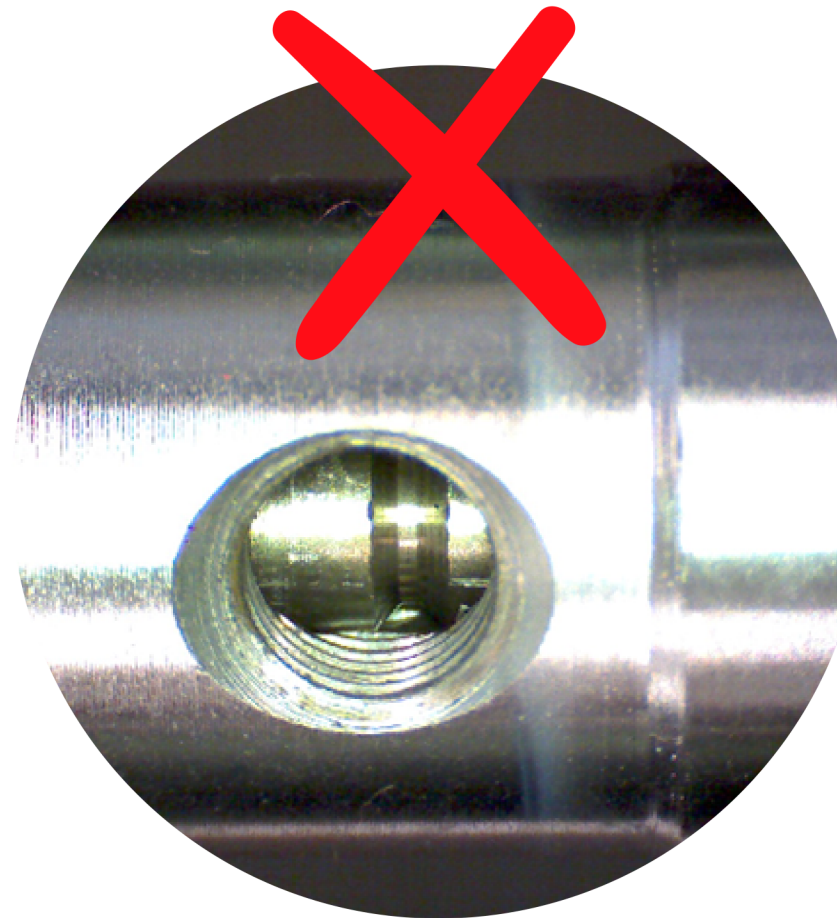
Cable inserted  
too far

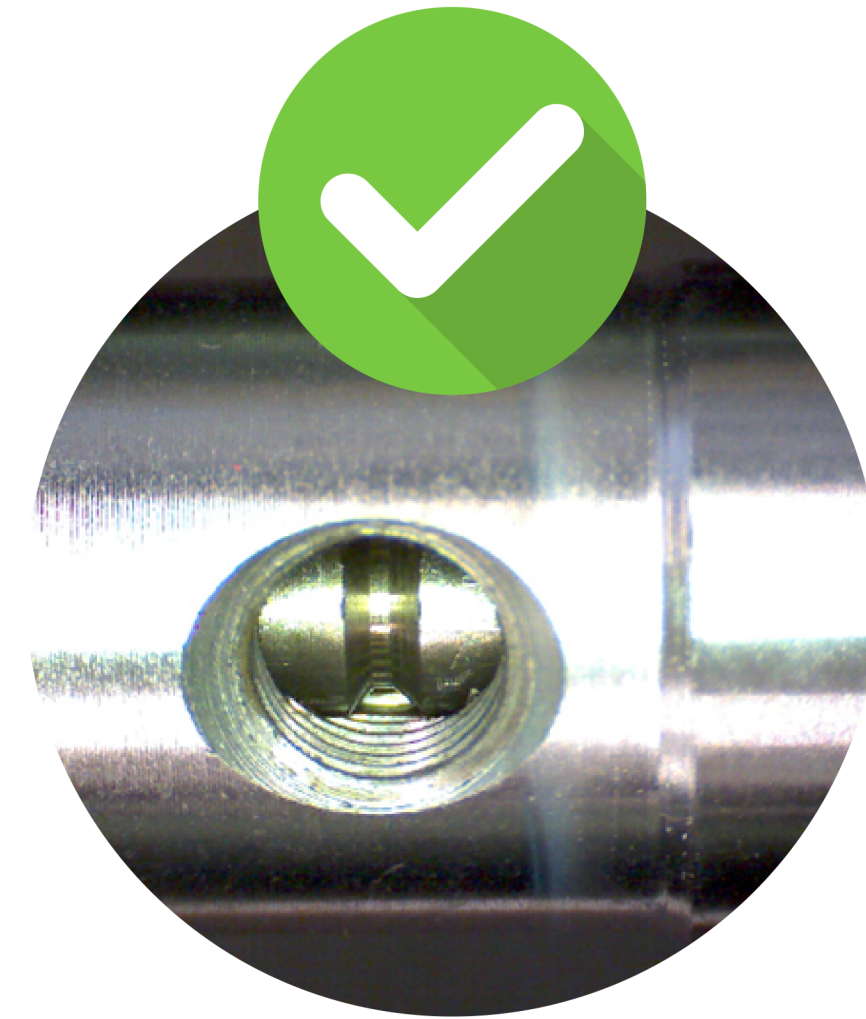
Cable inserted  
properly

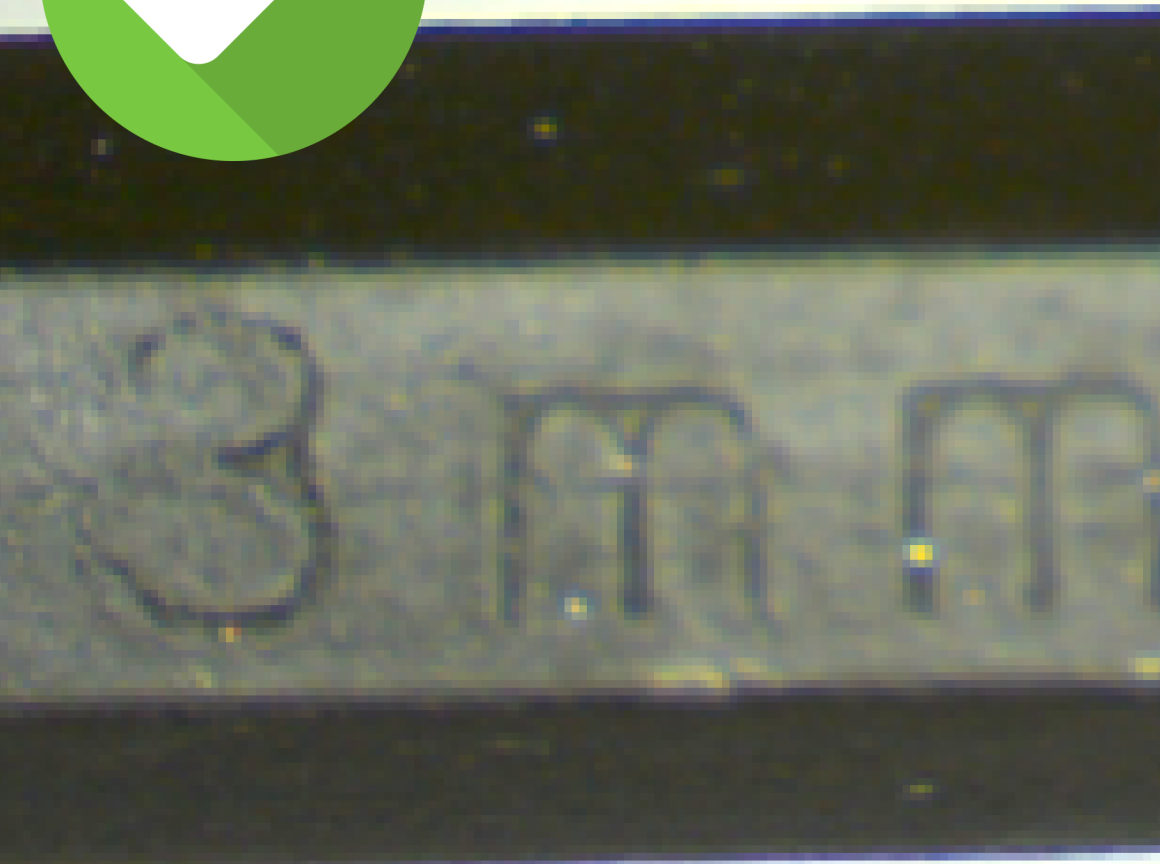
# Other Potential Causes of Loose Set Screws

## Incorrect Size Allen Key

- The print specs for this set screw shows a 3mm hex. It is very important that a 3mm Allen key be used, a 7/64" Allen key will fit the set screw **HOWEVER**, this will slip before securing the set screw to the correct torque.
- The same logic applies to a worn 3mm Allen key
